**Flood Control Project Maintenance
Levee Inspections
LMA District Cover Sheet
Spring 2010 Levee Inspection Results**

Reclamation District No. 1000 Natomas

Levee Inspection Report By Mile - Spring 2010

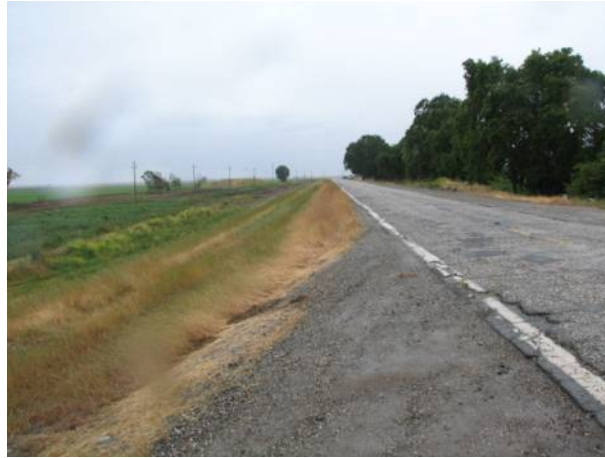
cathom_s_20100603_102.jpg

Levee Mile Report Line	1
Start Levee Mile	0.00
End Levee Mile	18.60
Location	Land Side
Category	Earthen Levee
Item	Vegetation

Land side vegetation levee mile 0.78.

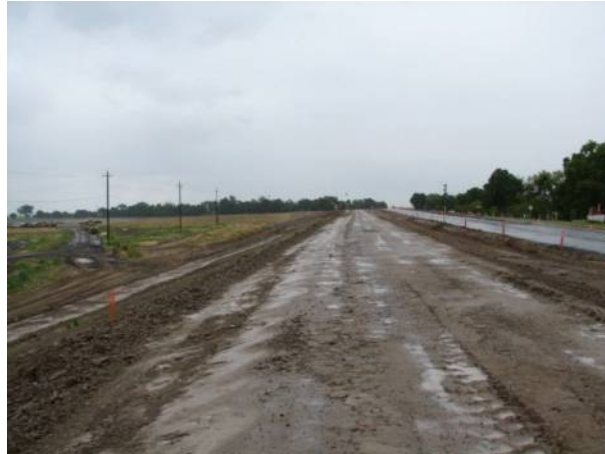
cathom_s_20100603_103.jpg

Levee Mile Report Line	1
Start Levee Mile	0.00
End Levee Mile	18.60
Location	Land Side
Category	Earthen Levee
Item	Vegetation

Land side North end of new levee, levee mile 0.00.

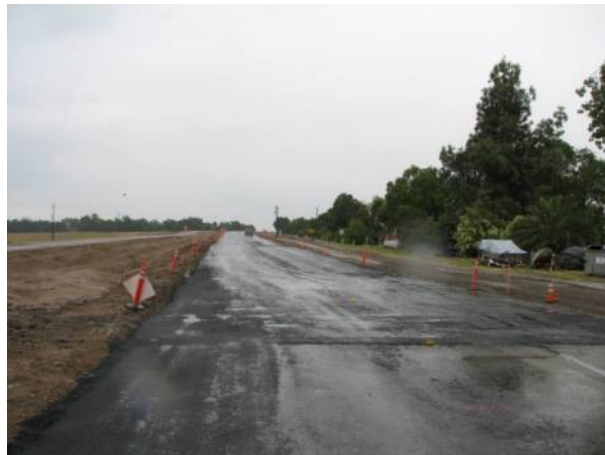
cathom_s_20100603_104.jpg

Levee Mile Report Line	2
Start Levee Mile	0.00
End Levee Mile	18.60
Location	Water Side
Category	Earthen Levee
Item	Vegetation

Water side North end of new levee, levee mile 0.00.

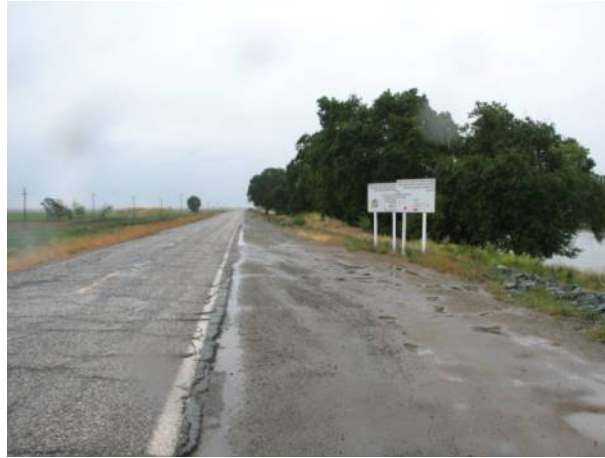
cathom_s_20100603_105.jpg

Levee Mile Report Line	2
Start Levee Mile	0.00
End Levee Mile	18.60
Location	Water Side
Category	Earthen Levee
Item	Vegetation

Water side vegetation levee mile 0.78.

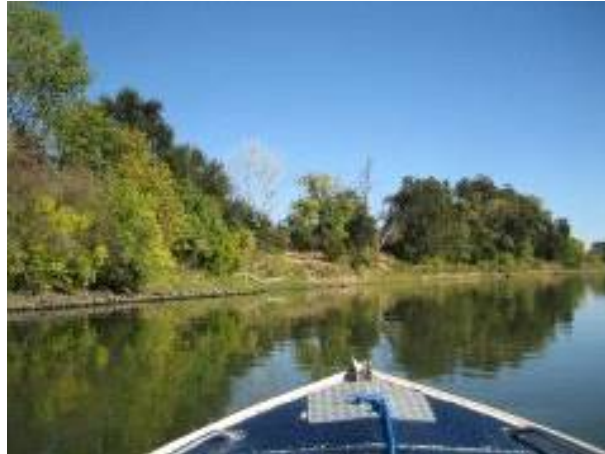
USACE2009_SAC_78-3_L_2009_09_16-D2P59_small.JPG

Levee Mile Report Line	5
Start Levee Mile	0.48
End Levee Mile	0.61
Location	Water Side
Category	Supplemental
Item	USACE Erosion Survey

2009: 15 ft berm, 2.5:1 slope, seepage, clays and silts, 4.89 ft/s [2009 SiteID:SAC_78-3_L]

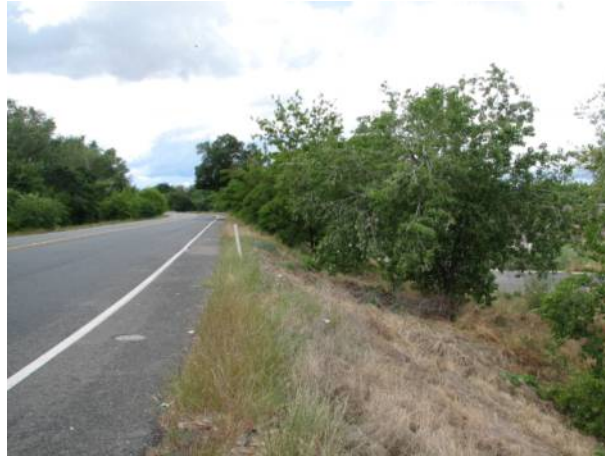
Levee Mile Report Line	1
Start Levee Mile	0.07
End Levee Mile	2.30
Location	Land Side
Category	Earthen Levee
Item	Encroachments
Land side encroachment, landscaping, levee mile 1.68.	
cathom_s_20100603_106.jpg

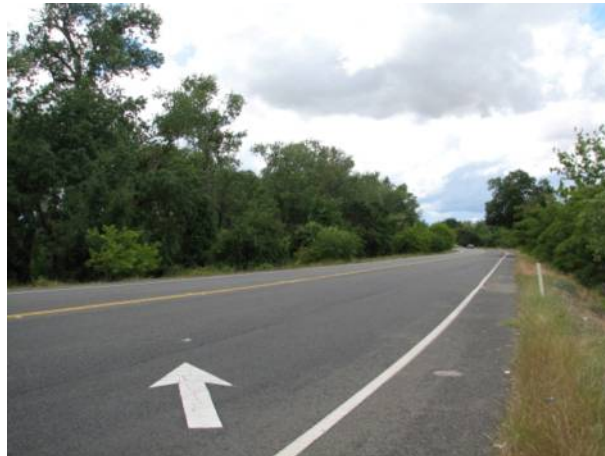
Levee Mile Report Line	2
Start Levee Mile	1.50
End Levee Mile	1.70
Location	Water Side
Category	Earthen Levee
Item	Encroachments
Water side encroachment, landscaping, levee mile 1.68.	
cathom_s_20100603_107.jpg

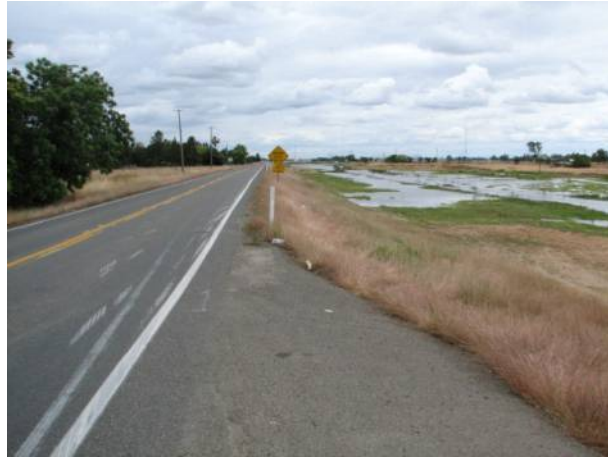
cathom_s_20100603_097.jpg

Levee Mile Report Line	5
Start Levee Mile	5.83
End Levee Mile	16.07
Location	Water Side
Category	Earthen Levee
Item	Vegetation

Water side vegetation levee mile 5.83.

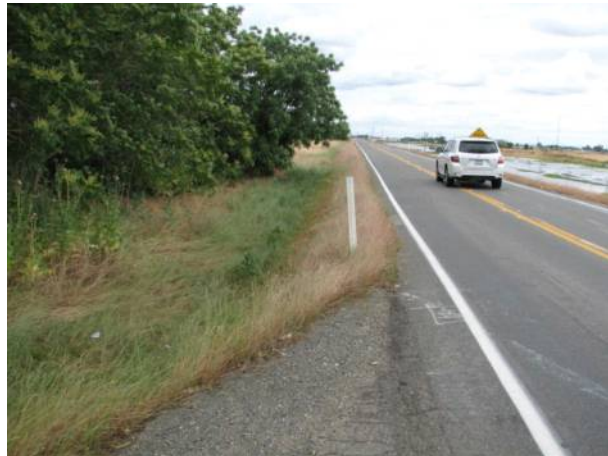
cathom_s_20100603_096.jpg

Levee Mile Report Line	6
Start Levee Mile	5.83
End Levee Mile	16.07
Location	Land Side
Category	Earthen Levee
Item	Vegetation

Land side vegetation levee mile 5.83.

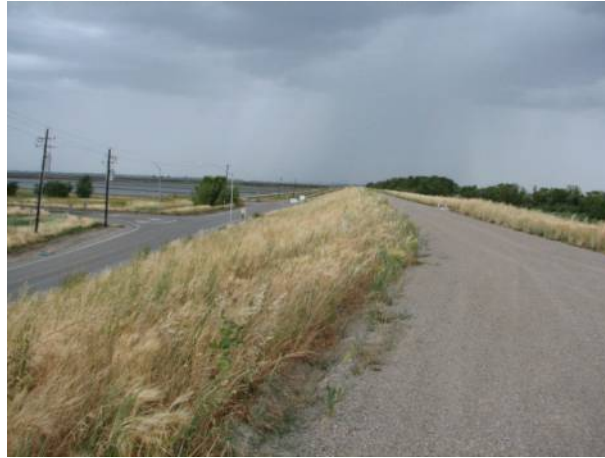
cathom_s_20100603_098.jpg

Levee Mile Report Line	1
Start Levee Mile	0.03
End Levee Mile	4.33
Location	Land Side
Category	Earthen Levee
Item	Vegetation

Land side vegetation levee mile 0.00.

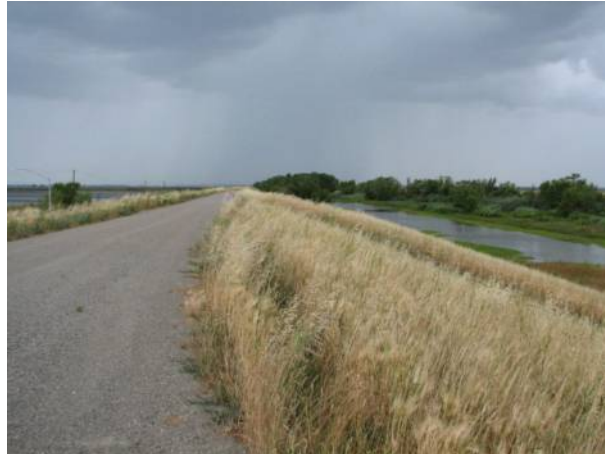
cathom_s_20100603_099.jpg

Levee Mile Report Line	2
Start Levee Mile	0.03
End Levee Mile	4.33
Location	Water Side
Category	Earthen Levee
Item	Vegetation

Water side vegetation levee mile 0.00.
